WASTE WATER PLANT DIGESTER SEALED WITH BELZONA

Customer Location: City of Hannibal, Missouri USA
Application Date: August 2003

Leaking expansion joints at digester top

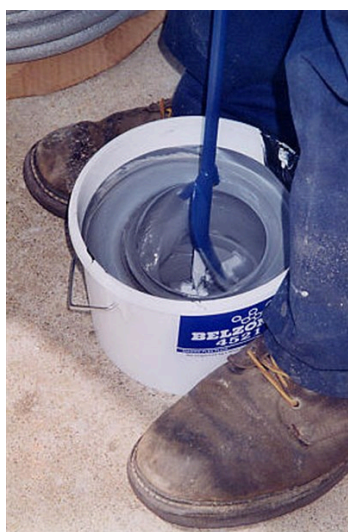
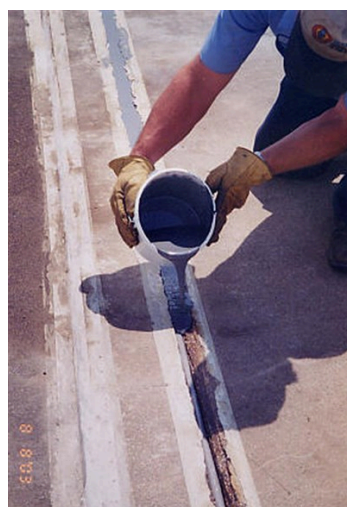
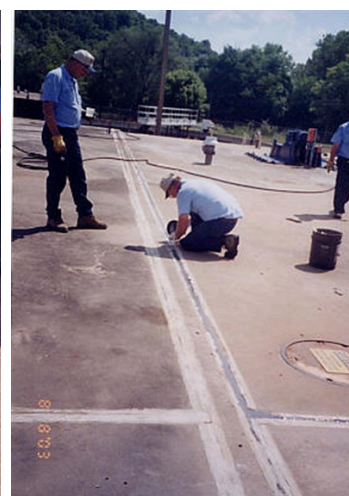
Loss of oxygen rich gas caused customer to re-enrich with oxygen monthly. Design conditions called for re-enrichment only three times per year.

- * Overview of the digester top. ,
- * Mixing Belzona® 4521. ,
- * Casting the joint. ,
- * Close up of joint. ,

Application was carried out in accordance with Belzona Know-How System Leaflet TCC-12.

Yearly cost for enrichment dropped from \$72,000 to \$18,000 after the repairs. This success led to overhaul of several water plant pumps.
