# BELZONA SEALS ASH VALVE

ID: 674

Customer Location: *Cement Works, Usje, Macedonia*  
Application Date: *December 2003*

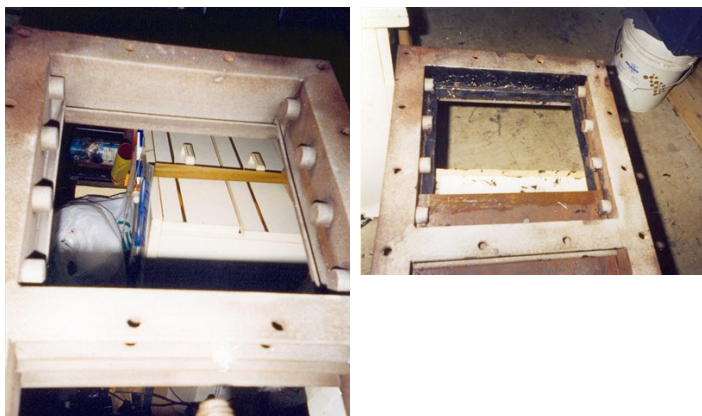
*Poor sealing between the steel gate and the valve housing meant that there was a 2-3 mm gap all around the seal area.*

- \* Ash valve ,
- \* Ash valve during repair ,

Application was carried out in accordance with Belzona® Know-How System Leaflet GSS-5.

Although the ash valve was new the poor seal allowed ash to escape and pollute the surroundings. The client was delighted with the outcome of this upgrade which avoided the need to replace the valve. Subsequently 6 others were done in the same way.
