BELZONA PROTECTS CEMENT PACKING MACHINE STEEL PLATES

Application: SHM-Solids Handling Machinery

Customer Location: Cement Works, Usje, Macedonia

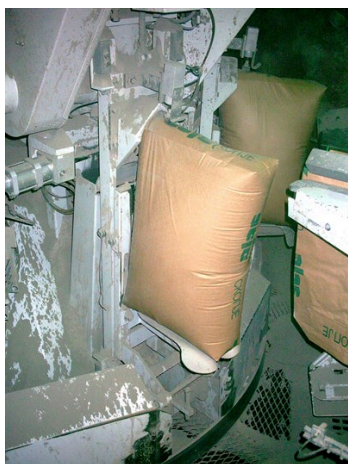
- * Cement packing machine. ,
- * Condition of the coated steel plate and steel seat after one year in service. (Experiment which shows no wear after one year). ,
- * Repaired seats and sheets. ,

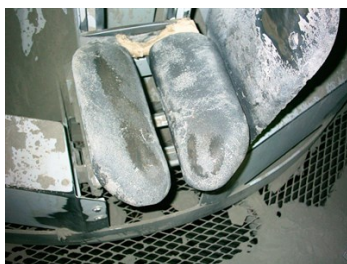
Initially done as an experiment, the cheapest base metal was chosen and coated with Belzona. One year later the plates were inspected and were found have suffered from no wear at all. Belzona® 1812 would be expected to give similar results.

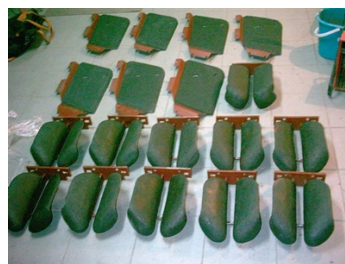
Deterioration of the steel plates and steel seats due to wear from the cement bags.

Steel plates and steel seats of a cement packing machine.

Application was carried out in accordance with Belzona Know-How System Leaflet SHM-13.
