# BELZONA ELECTRICAL CONDUITS MADE SAFE

Customer Location: Coal Fired Power Plant in North Texas

Application: GSS-Gaskets, Seals and Shims

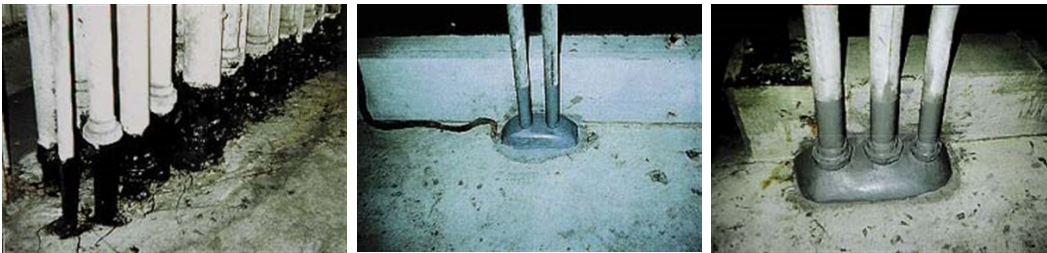
Sulfur in lignite (coal) combines with water (moisture) to form a weak sulfuric acid that corrodes the conduit.

- \* Big bank of electrical conduit sealed with Belzona® 2111. ,
- \* Another electrical conduit top dressed with Belzona® 4131. ,
- \* Close-up view of conduit, also coated with Belzona® 3921 for corrosion protection. ,

The application was carried out in accordance with a modified version of Belzona Know-How Leaflet GSS-4.

If the conduit corrodes, the high voltage electrical cables (4000-6000 volts) inside pose a severe safety issue during cleaning. The Belzona application saved hundreds of thousands of dollars as the alternative to this repair is to run new electrical cables.
