# BELZONA PROTECTS RUBBER PIPES AT WWTP FROM UV ATTACK

ID: 681

Customer Location: Wastewater Treatment Plant, BC,  
Canada

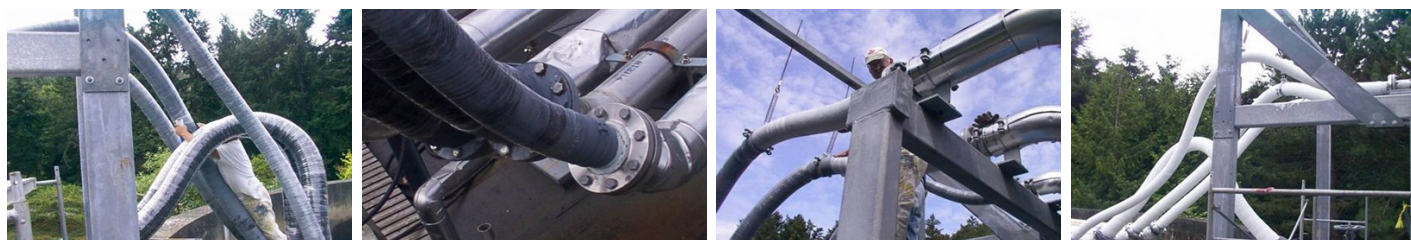
## Photograph Descriptions

- \* Preparation of flexible hoses in progress. All pipes are tightly wrapped with a polythene film to prevent bleed through of the pitch from the rubber component. ,
- \* The flanges are ground and coated with Belzona® 3921 GSC Conditioner. ,
- \* Application of Belzona® 3211 in progress. Belzona® 9311 Reinforcement cloth is incorporated into the 1st coat. ,
- \* Completed application. ,

UV attacks the rubber over a period of time causing it to degrade and eventually become brittle.

Flexible rubber transfer pipes on digester

Application carried out in accordance with a modified version of Belzona System Leaflet VPF-12.
