# BELZONA REBUILDS NON-SLIP SAFETY SYSTEM FOR INDOOR POOL AREA

**Industry:** Buildings & Structures  
**Application:** FPA-Floor Problem Areas  
**Substrate:** Ceramic tiles  
**Products:** \* Belzona 4111 (Magma-Quartz) ,  
\* Belzona 4911 (Magma TX Conditioner) ,

**Customer Location:** Whistler, BC, Canada  
**Application Date:** November 2003

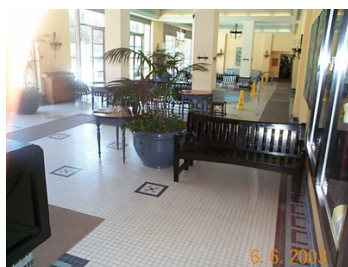
The tile surface was extremely slippery so customer had to use special non-slip mats to cover the walk areas. Non-slip mats did not give a good appearance to the atmosphere and smelled.

- \* 1. View of Whistler Fairmont Resort Hotel ,
- \* 2. A general view of the Health Club showing the floor mats in place ,
- \* 3. When the product had cured, the area was swept with a broom and vacuumed. ,
- \* 4. View of completed application covering approximately 700 sq.ft ,
