BELZONA REBUILDS BEARING SURFACE ON PAPER MACHINE DRIVE

ID: 683

Industry: *Pulp & Paper*
Application: *MPT-Mechanical Power Transmission*

Customer Location: *Pulp & Paper Operation, BC, Canada*
Application Date: *2001*

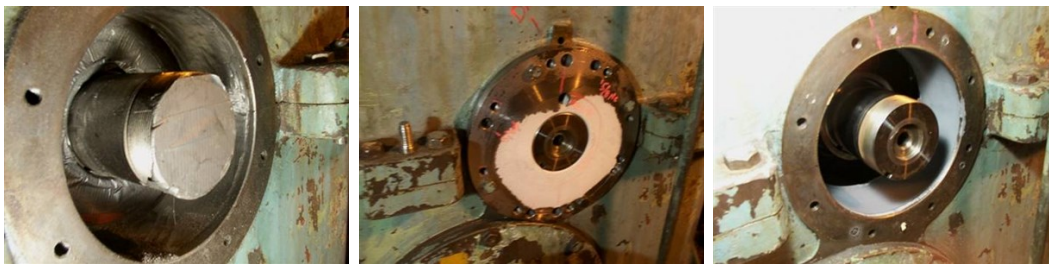
Photograph Descriptions

The worn bearing fit on the paper machine drive was causing gear lash problems.

- * The bearing fit area ground to provide a rough surface and degreased with Belzona® 9111 ,
- * The mold was positioned carefully before injecting Belzona® 1321 (Ceramic S Metal) ,
- * The mold removed, revealing a perfectly formed new bearing surface ,

Application carried out in accordance with Belzona Know-How System Leaflet MPT-7.

There is a long and successful history of using this type of repair procedure in these facilities without any failures. This application also saves a great deal of downtime as there is no need to disassemble the housing.
