BELZONA REBUILDS DAMAGED DRYER CAN JOURNAL IN 5 HOURS

ID: 684

Industry: *Pulp & Paper*
Application: *MPT-Mechanical Power Transmission*

Customer Location: *Pulp & Paper Operation, BC, Canada*
Application Date: *2004*

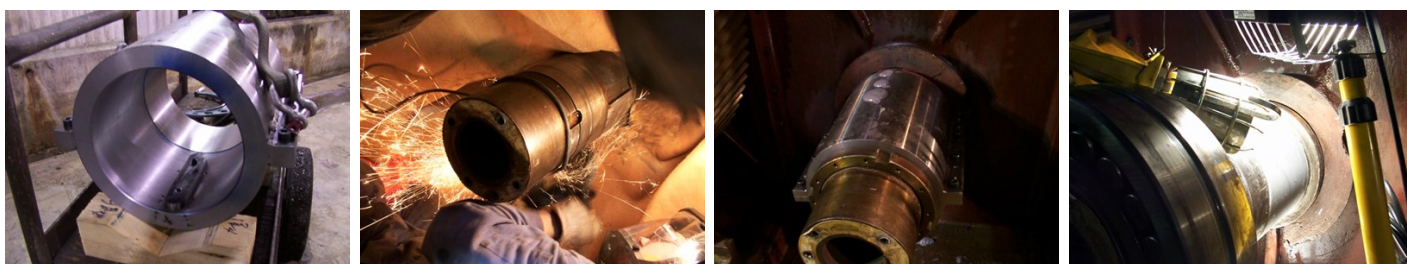
Photograph Descriptions

There was a fit problem with the gear causing excessive vibration when it was running

- * View of completed mold with new keyway fitted ,
- * Grinding of the damaged journal underway ,
- * The mold has been fitted and the Belzona 1391 HT Ceramic injected - see excess coming out of vent holes on top of mold. ,
- * Mold removed revealing rebuilt journal ,

Damaged dryer can journal

Application carried out in accordance with Belzona Know-How System Leaflet MPT-2.

Because of the complexities associated with the intended application, the entire application procedure was pre-planned prior to a scheduled shutdown. As a result the application proceeded extremely smoothly.
