BELZONA REBUILDS DAMAGED DRYER CAN JOURNAL IN 5 HOURS

ID: 684

Industry: *Pulp & Paper*
Application: *MPT-Mechanical Power Transmission*

Customer Location: *Pulp & Paper Operation, BC, Canada*
Application Date: *2004*

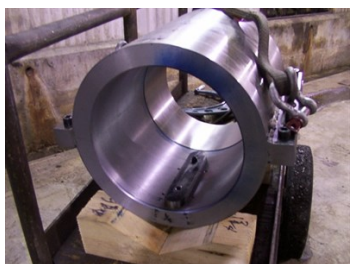
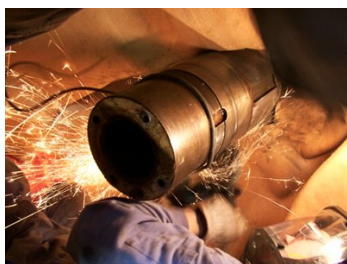
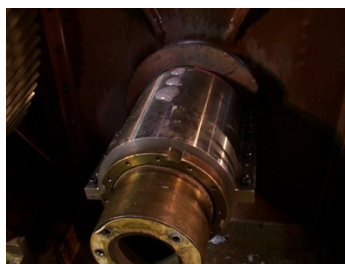
Photograph Descriptions

There was a fit problem with the gear causing excessive vibration when it was running

- * View of completed mold with new keyway fitted ,
- * Grinding of the damaged journal underway ,
- * The mold has been fitted and the Belzona 1391 HT Ceramic injected - see excess coming out of vent holes on top of mold. ,
- * Mold removed revealing rebuilt journal ,

Damaged dryer can journal

Application carried out in accordance with Belzona Know-How System Leaflet MPT-2.

Because of the complexities associated with the intended application, the entire application procedure was pre-planned prior to a scheduled shutdown. As a result the application proceeded extremely smoothly.
