BELZONA SEALS EXPOSED PARKING DECK SEAMS

ID: 687

Customer Location: Surrey, BC, Canada
Application Date: Ongoing since 2000

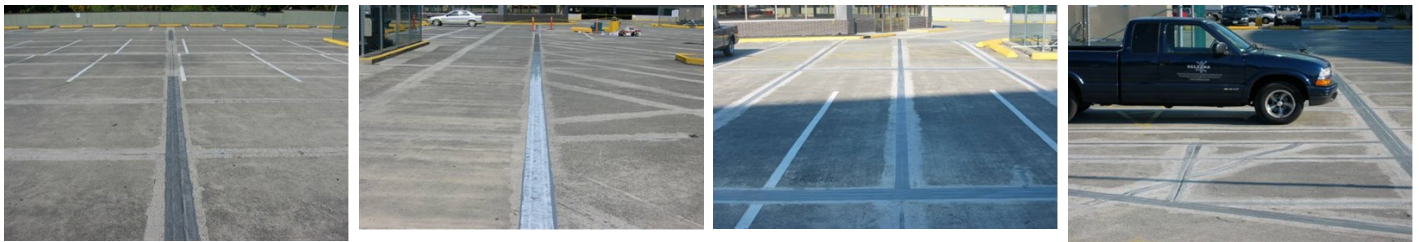
Photograph Descriptions

Customer was looking for a long lasting solution for sealing seams on an exposed concrete parking deck.

- * Initial test area after more than 2 years service ,
- * Application in progress - 1st coat with Reinforcement Sheet in place ,
- * Application of 2nd coat in progress ,
- * Completed section of deck ,

Over 15000 linear feet of expansion joint seams needed to be sealed

Application was carried out in accordance with a modified version of Belzona Know-How System Leaflet RPA-1.

Test strips were installed at the site in 2000. Both 3111 and 3121 were submitted. Both products performed well showing no deterioration after 2 years. Belzona 3121 was chosen for its relative ease of application. Application has been spread over 3 years with a total of about 15,000 linear feet of seams completed
