BELZONA PROTECTS FLANGES OF CONCRETE LINED PIPEWORK

Customer Location: Power Station, Germany
Application Date: August 2002

Installation of additional valves into concrete lined cooling water pipework (ranging from 400-1200mm)

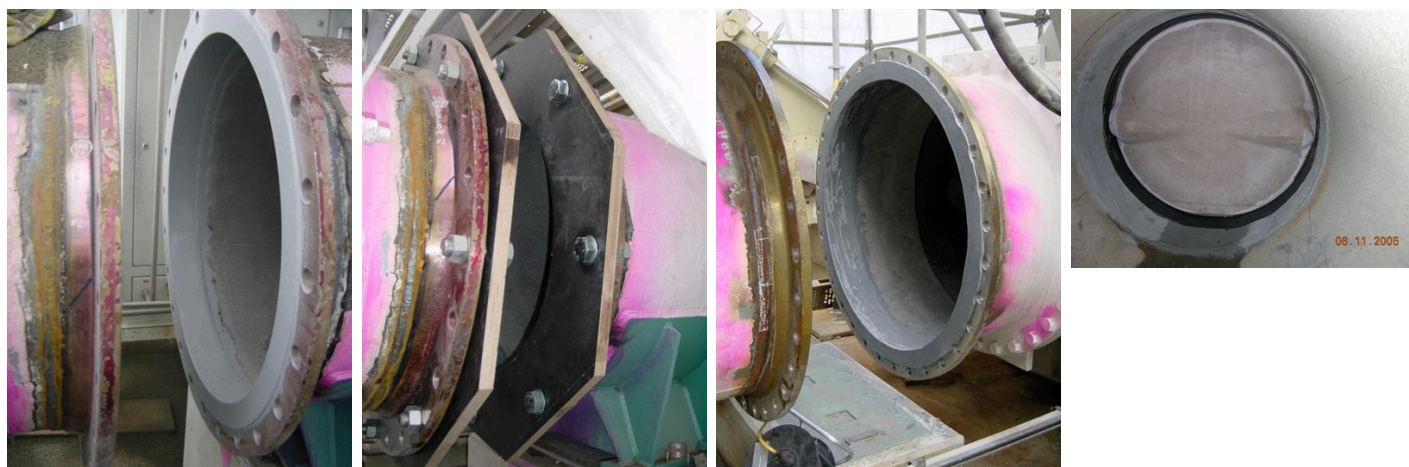
The cutting of the pipes damaged the concrete lining and would have resulted in crevice corrosion on the flange face and corrosion creep under the concrete. It was not practical to repair the concrete with more concrete.

- * Blasted steel flange face – note concrete lining also prepared ,
- * Use of formers as per VPF-13. ,
- * Completed application ,
- * Inspection after 3 years service ,

Application was carried out in accordance with Belzona Know-How System Leaflets VPF-3, -13.

Fourteen Flanges were protected and all works completed within two days. The cooling water system operates with a maximum pressure of three bar. After inspection following three years service, the satisfied client has specified the use of Belzona 1111 for other damaged concrete lined pipes
