# BELZONA REPAIRS CRACKED STEEL TUNNEL

Customer Location: *Cement Works, Usje, Macedonia*  
Application Date: *September 2004*

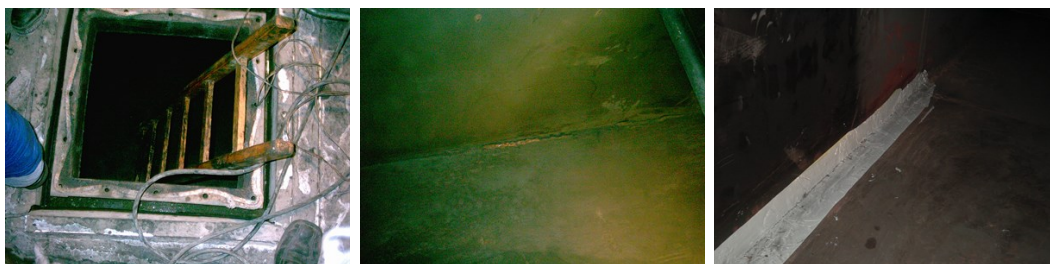
## Photograph Descriptions

*A 700mm long crack had appeared on the weld joint of the steel walls*

- \* Steel tunnel entrance ,
- \* Crack in steel tunnel ,
- \* Belzona® 1221 repair ,

Application was carried out in accordance with Belzona Know-How System Leaflet ENC-1.

The customer had tried to apply Silicone under the crack but it had failed within a month. This Belzona solution was designed to be a temporary solution to last 3 months until the plant was shut down when a weld repair could be carried out. The customer was very pleased with the outcome and the costs which were saved through not having to shut the plant down earlier than planned.
