# BELZONA REPAIRS CORRODED ROOF OFFSHORE PLATFORM

ID: 694

Customer Location: Oil and Gas Company, UK North Sea  
Application Date: July 2004

Heat recovery unit roof on offshore production platform

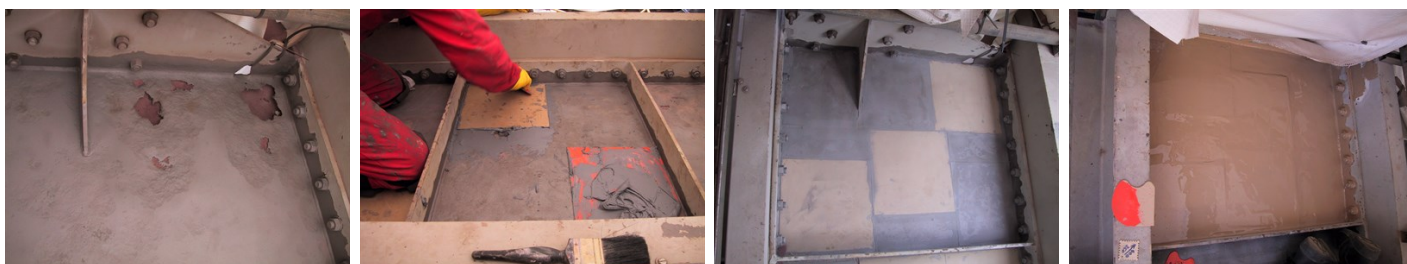
Salt water had collected on the roof and combined with the heat from beneath had caused rapid corrosion. The roof had holed in numerous places.

- \* Holed steel roof ,
- \* Application of Belzona® 1111 ,
- \* Repaired surface ,
- \* Protected surface ,

Application was carried out in accordance with modified Belzona Know-How System Leaflets RPA-7 & TCC-5. Steel plates were bonded on using Belzona® 1111 and then protected with Belzona® 5811.
