BELZONA PROVIDES LONG TERM PROTECTION IN HIGH TEMPERATURE SULPHUR

ID: 695

Industry: *Oil & Gas*
Application: *VPF-Valves, Pipes and Fittings*
Substrate: *Carbon Steel*
Products: ** Belzona® 1591 (Ceramic XHT),*

Customer Location: *Oil Refinery, United Kingdom*
Application Date: *1997*

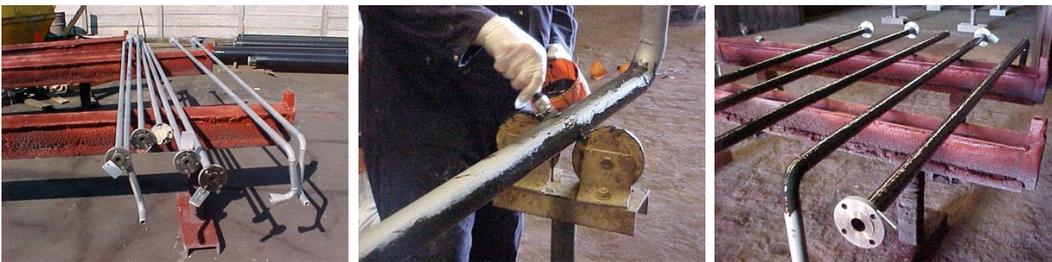
Sulphur at 118-128°C was causing high levels of corrosion.

- * Pipes ready for application ,
- * Brush application of Belzona® 1591 ,
- * Coated pipes ,

Application was carried out in accordance with Belzona Know-How System Leaflets VPF-2.

Initial application was done as a test. This application was still performing well four years later to the customers shock and delight. Since this initial application lids, pipework, viewports, manways, coil legs and pump externals have all been coated.
