BELZONA WEATHERPROOFS AIRPORT FIRE STATION ROOF

ID: 696

Industry: *Buildings & Structures*
Application: *RPA-Roof Problem Areas*
Substrate: *Concrete*
Products: ** Belzona® 3131 (WG Membrane) ,*

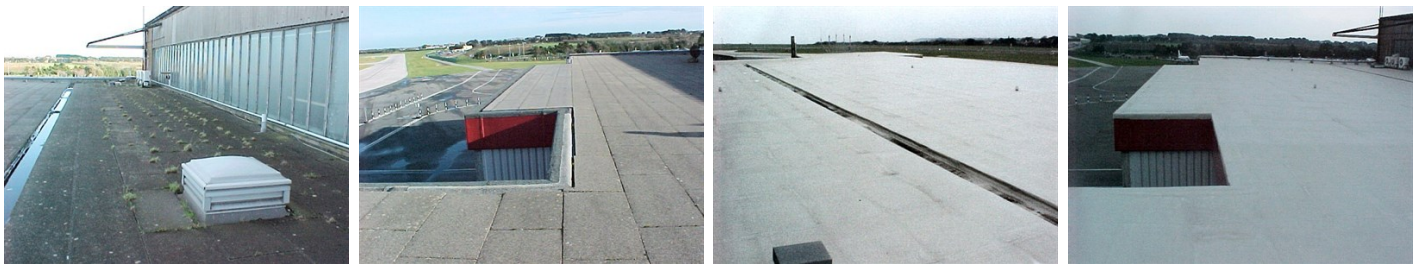
Photograph Descriptions

This fire station roof was leaking and the local airport authority wanted to repair it and extend its life, rather than a full replacement.

* 1. Roof to be coated
2. The roof after cleaning and surface preparation
3. Coated roof
4. Completed application ,

Application was carried out in accordance with Belzona® System Leaflet RPA-1

The unusual construction of this roof posed a problem for other roofing systems. Belzona was chosen as the solution, as the alternative was to completely replace the roof. 2 years on and the application is still in perfect condition.
