# BELZONA SOLVES COAL POWER PLANT ASH PIPE PROBLEM

Industry: Power  
Application: VPF-Valves, Pipes and Fittings  
Substrate: Cast Steel  
Products: \* Belzona® 1811 (Ceramic Carbide),

Customer Location: Coal Power Plant, Macedonia  
Application Date: October 2004

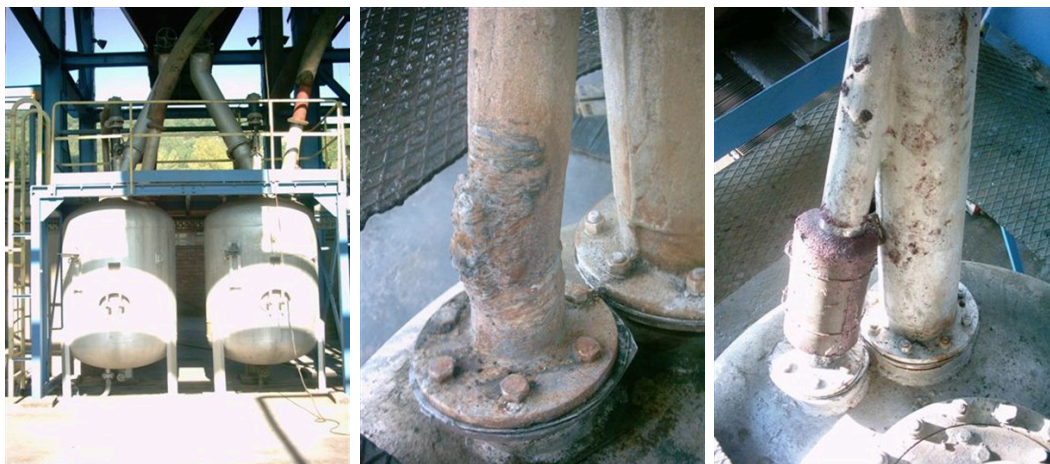
*Holed pipe caused by coal ash containing a high percentage of quartz*

- \* Application situation ,
- \* A traditional repair which had holed again ,
- \* The Belzona repair ,

Forked Ash Pipe

Every few weeks some of these pipes become holed and are traditionally welded. Welding these pipes is typically very difficult and after a very short time the problem reappears at the same point. After the application of the Belzona® solution at 30-40mm along with steel plates the problem stopped. By January 2006 there had been many of these repairs completed and none had become

holed again.
