# BELZONA GRIP SYSTEM HELPS POWER PLANT

Application: *SHM-Solids Handling Machinery*

Customer Location: *Coal Fired Power Plant, Macedonia*

Conveyor belt drive roller

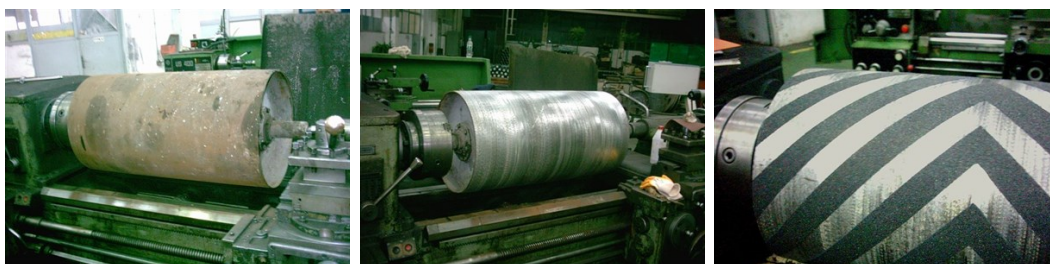
*The original rubber lagging had worn away and the loss in friction was allowing the belt to slip and lose efficiency.*

- \* Roller in poor condition prior to application ,
- \* Surface preparation ,
- \* Completed application ,

Application was carried out in accordance with Belzona Know-How System Leaflet SHM-12.
