COOLING TOWER FAN BLADES REPAIRED WITH BELZONA

Industry: *Chemical & Petrochemical*
Application: *HEX-Heat Exchangers*
Substrate: *Fiberglass Reinforced Polyester*
Products: ** Belzona® 1321 (Ceramic S-Metal) ,*

Customer Location: *Refinery in Louisiana*
Application Date: *1995*

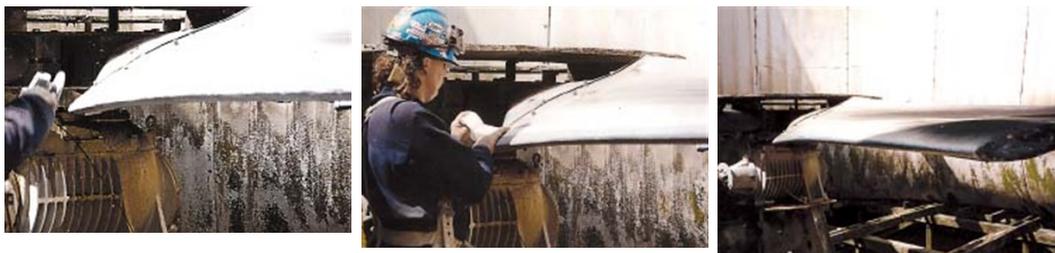
Photograph Descriptions

Light damage and erosion on the leading edge of the blades reduces the overall efficiency and operation of the cooling system.

- * Surface preparation by grinding. ,
- * Taping off for a neat repair. ,
- * Finished repair. Leading edge protected with Belzona. ,

The application was carried out in accordance with Belzona Know-How Leaflet HEX-10.

After 14 months, fiberglass blades on new units needed replacement at a cost of \$125,000. Over two years later the Belzona repair is in excellent condition. The plant has saved over \$200,000 in new blade replacement cost.
