# COOLING TOWER FAN BLADES REPAIRED WITH BELZONA

Industry: *Chemical & Petrochemical*  
Application: *HEX-Heat Exchangers*  
Substrate: *Fiberglass Reinforced Polyester*  
Products: *\* Belzona® 1321 (Ceramic S-Metal) ,*

Customer Location: *Refinery in Louisiana*  
Application Date: *1995*

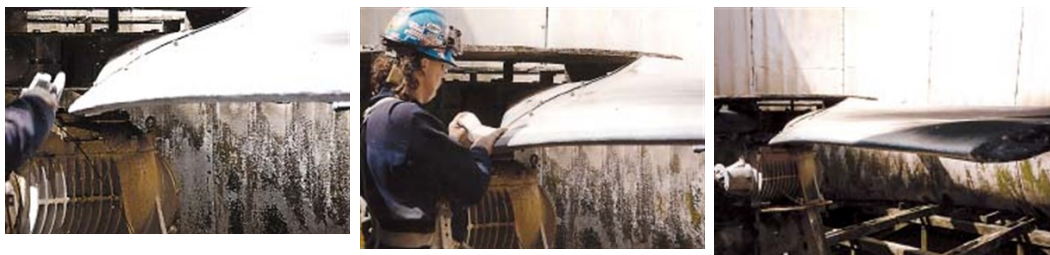
*Light damage and erosion on the leading edge of the blades reduces the overall efficiency and operation of the cooling system.*

- \* Surface preparation by grinding. ,
- \* Taping off for a neat repair. ,
- \* Finished repair. Leading edge protected with Belzona. ,

The application was carried out in accordance with Belzona Know-How Leaflet HEX-10.

After 14 months, fiberglass blades on new units needed replacement at a cost of \$125,000. Over two years later the Belzona repair is in excellent condition. The plant has saved over \$200,000 in new blade replacement cost.
