# BELZONA SEALS LEAKING TRANSFORMER FLANGES

ID: 700

Customer Location: Electricity Supplier, British Columbia, Canada

Electricity Transformer Flanges

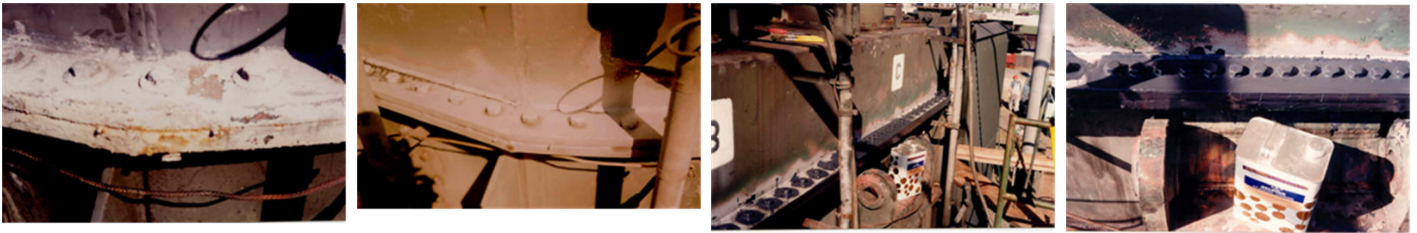
Oil was leaking out between the flanges.

- \* View of oil covered flange ,
- \* Flanges degreased and blasted to provide a good rough surface profile ,
- \* Application in progress with bolts being sealed first ,
- \* Completed application ,

Application carried out in accordance with a modified version of Belzona Know-How Leaflet TCC-2.

Using Belzona allowed the repair to be completed without having to remove the top from the transformer, which would have resulted in many hours of outage time.
