BELZONA REPAIRS LEAKING TRANSFORMER

ID: 704

Electricity Transformer

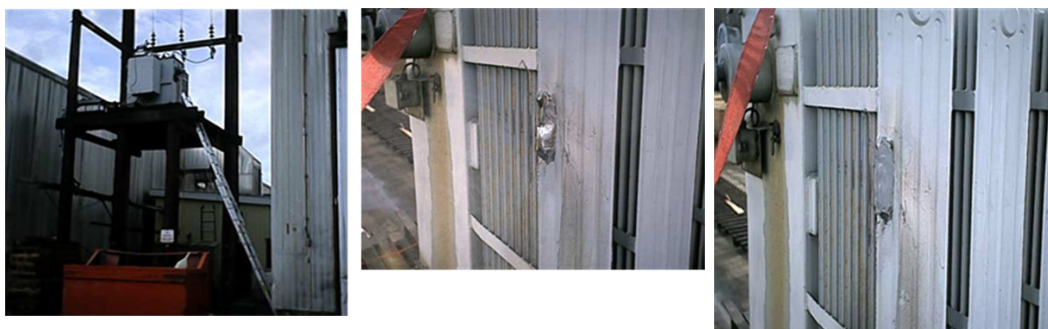
Photograph Descriptions

The cooling fins of the transformer had been damaged. Previous repairs lasted only a short while.

- * View of leaking transformer. ,
- * Surface preparation completed. ,
- * After initially sealing the hole with Belzona® 1221 Super E Metal area received a final overcoating layer of Belzona® 1111 Super Metal. ,

Application carried out in accordance with Belzona Know-How System Leaflet VPF-1 and VPF-2.

Rebuilding the damaged area provided a quick and simple solution to a constant problem area and was accomplished with the minimum amount of downtime.
