# BELZONA REPAIRS AND IMPROVES FRANCIS TURBINE RUNNER

ID: 707

Francis Turbine Runner

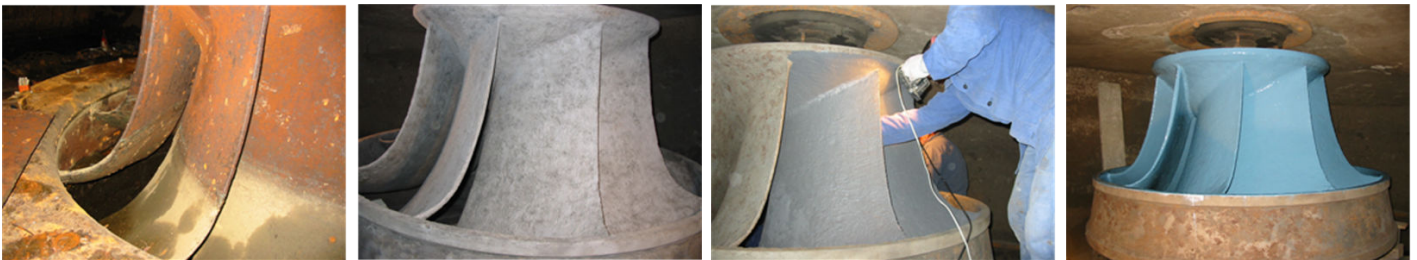
## Photograph Descriptions

*The runner had suffered extensive damage from erosion, corrosion and mechanical damage.*

\* Damaged and worn runner After grit blasting Rebuilding with Belzona® 1111 After coating with Belzona® 1341 ,

The application was carried out in accordance with Belzona® Know-How System Leaflets CEP-8 and CEP-10.

After the repair and coating of both the runner and wicket gates a 10 - 15% increase in output was recorded and the turbines were able to run at a greater range of heads than were possible before, thus earning the customer many time more in profit than the cost of the repair. After one year operation the runner was inspected and was found to have only suffered minor damage due to impact with pieces of wood. A further inspection in 2006 showed runner still to be in excellent condition and in 2010 client expressed himself happy with the application.
