BELZONA PROTECTS HYDROELECTRIC TURBINES

Customer Location: Hydroelectric Power Plant, Czech Republic

Application: CEP-Centrifugal Pumps

Two Kaplan Turbines

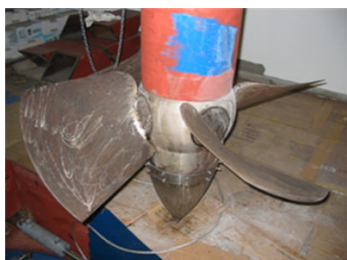
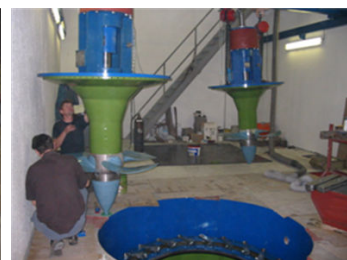
Photograph Descriptions

Erosion caused by entrained particles in the water, there was also corrosion damage present.

* 1. Damaged Turbine 2. Application Situation 3. Coated Blades 4. Completed Application ,

The application was carried out in accordance with Belzona® Know-How System Leaflet CEP-10.

Belzona® 1341 was chosen for it's excellent erosion protection, as well as enhancing the efficiency of the turbines.
