# REBUILD AND PROTECTION OF A FRANCIS TURBINE WITH BELZONA

Customer Location: Hydroelectric Power Plant, Czech Republic

Francis turbine runner

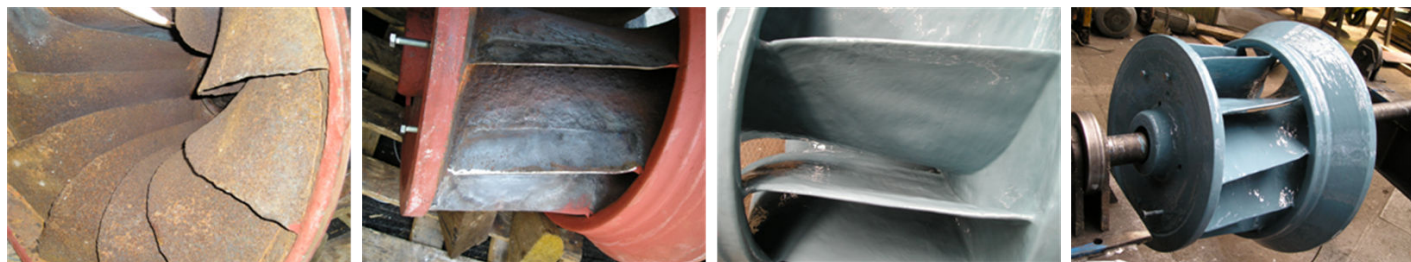
The turbine was not running efficiently due to extensive erosion and corrosion damage.

\* Application Situation , \* After Grit Blasting , \* After Rebuilding With Belzona® 1111 , \* After Coating With Belzona® 1341 ,

The application was carried out in accordance with Belzona Know-How System Leaflets CEP-8 and -10

The client had tried to repair the blades with weld repairs but these had caused the blades to distort and warp. The Belzona was an attractive solution because it was quick and simple to rebuild the damaged blades and to protect and enhance the efficiency of the turbine with Belzona materials.
