BELZONA REPAIRS A HYDROELECTRIC TURBINE

Customer Location: Hydroelectric Power Plant, France

Francis Turbine

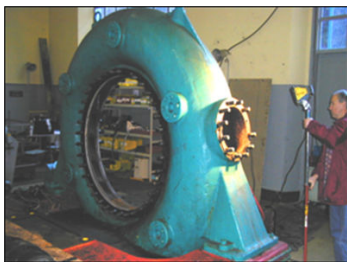
* 1. The Francis turbine 2. The extent of the damage 3. The completed application 4. Turbine after 11 years in service ,

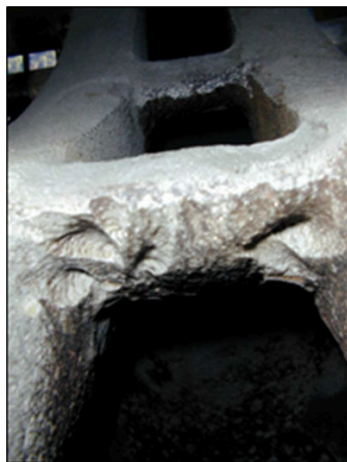
Erosion, corrosion and cavitation of the stay vanes and the casing had induced vibration into the turbine and was also making the turbine run inefficiently.

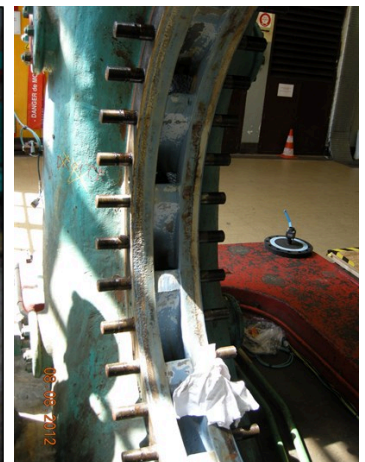
Once back in service the turbine once again achieved its maximum efficiency. The coatings were also chosen to protect the turbine from further damage. An inspection of the turbine following 11 years of service showed that the repair was in excellent condition with only minor damage to the coating, due to erosion from entrained solids, being observed.
