BELZONA REBUILDS AND PROTECTS A BULB TURBINE BODY

Customer Location: *Hydroelectric Power Plant, Drome, France*

Application: *CEP-Centrifugal Pumps*

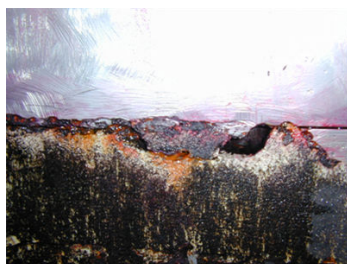
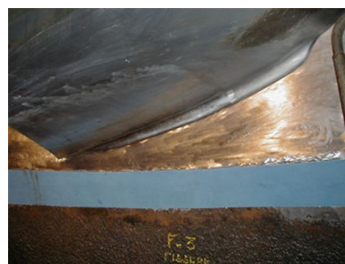
Severe galvanic corrosion between inox and steel leading to water infiltration.

* Application situation The problem The solution ,

Bulb Turbine

The application was carried out in accordance with Belzona Know-How System leaflets CEP-8 & CEP-10.

The greatest benefit was that the application could be done very quickly, in situ and without hot work. The application of Belzona meant the plant was back in service in the least time possible. Five years later the turbine was inspected and found to be in perfect condition. The galvanic corrosion problem had been completely solved.
