# BELZONA REBUILDS AND PROTECTS TURBINE RUNNER HUB

ID: 717

Customer Location: Hydroelectric Power Plant, France  
Application Date: July 2003

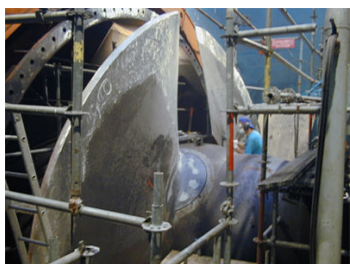
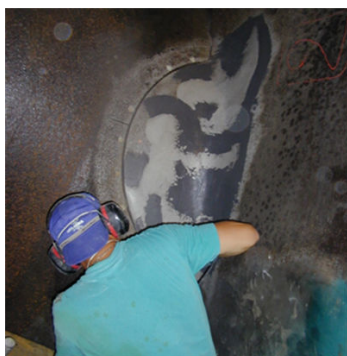
*The turbine hub had suffered from erosion due to cavitation.*

- \* Large Kaplan Turbine ,
- \* Application underway ,
- \* Completed repair and protection ,

The application was carried out in accordance with Belzona Know-How System Leaflets CEP-5 and CEP-8.

This repair and protection prolonged the life of this turbine and meant that inspection and repairs were required less frequently.
