# BELZONA EXTENDS LIFE OF CONDENSER EXPANSION JOINT

Customer Location: *Power plant, Egypt.*

The rubber expansion joint of the main condenser of the plant.

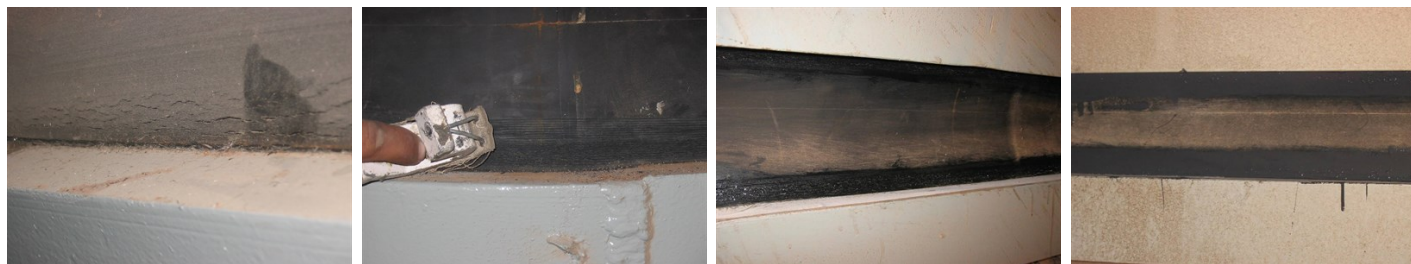
*Both sides, top and bottom, of the rubber flexible joint had deteriorated.*

- \* The deteriorated rubber joint ,
- \* Surface preparation of the joint ,
- \* Conditioning the surface ,
- \* Belzona® 2221 applied ,

Application was carried out in accordance with modified version of Belzona® Know-How System leaflet SHM-9.

Belzona® 2221 was able to quickly and successfully repair the rubber joint on the spot, extending its life without disrupting operation of the plant.
