# BELZONA SAVES RECYCLING DRUM AT PAPER MILL

ID: 72

**Industry:** *Pulp & Paper*  
**Application:** *TCC-Tanks and Chemical Containment Areas*

**Customer Location:** *Paper Mill in North America*  
**Application Date:** *April 1997*

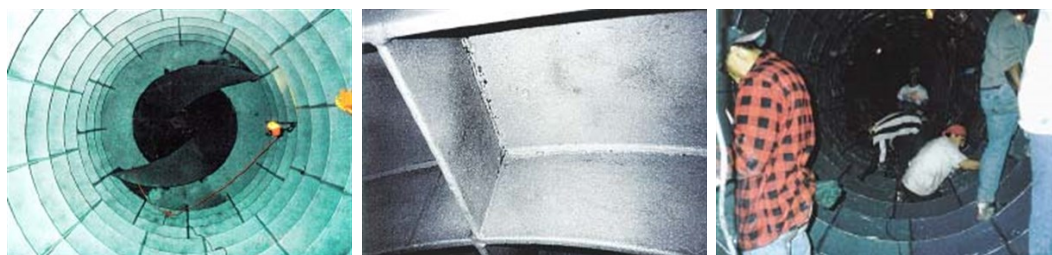
## Photograph Descriptions

*Bi-metallic corrosion on approximately 70% of the weld.*

- \* Entrance to 30' long and 10' diameter recycling drum. ,
- \* Close-up view of corroded seams. ,
- \* Seam areas rebuilt with Belzona® 1311. Entire drum received two coats of Belzona® 1321 for erosion/corrosion protection. ,

The application was carried out in accordance with a modified version of Belzona Know-How Leaflet TCC-5.
