# BELZONA GLAND HOUSING REBUILD

ID: 720

Industry: Power  
Application: CEP-Centrifugal Pumps  
Substrate: Cast Iron.  
Products: Belzona® 1311 (Ceramic R-Metal)

Customer Location: Power plant , Egypt.  
Application Date: October 2006.

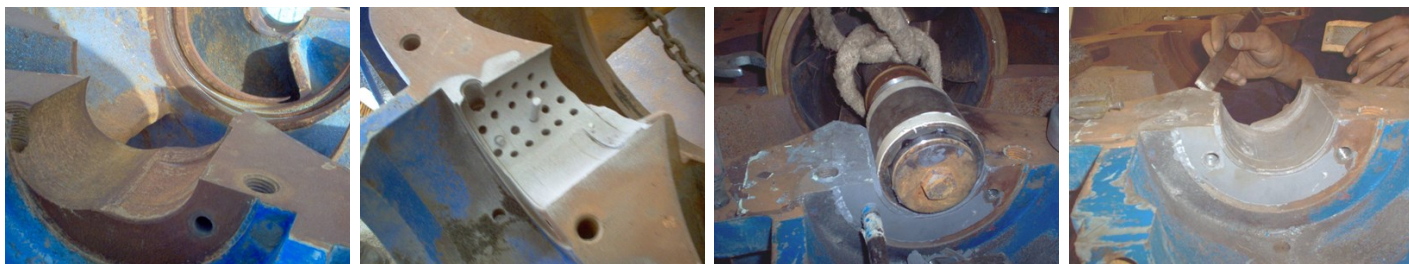
Gland housing of the pump was badly worn and damaged due to mechaical failure.

\* The damaged gland housing , \* Preparing the housing , \* Reforming the housing to its original dimensions , \* Repair completed ,

Application was carried out in accordance with Belzona Know-How System Leaflet CEP-2.

Belzona reformed gland housing back to original dimensions without heat and was completed in one day.
