# BELZONA OVERCOMES ROOF DESIGN FLAW

**Industry:** Buildings & Structures  
**Application:** RPA-Roof Problem Areas  
**Substrate:** Darby gum roofing sheets and metal flashing.  
**Products:** \* Belzona® 3111 (Flexible Membrane) ,

**Customer Location:** River Dam Authority, Vinita, OK  
**Application Date:** August, 2005

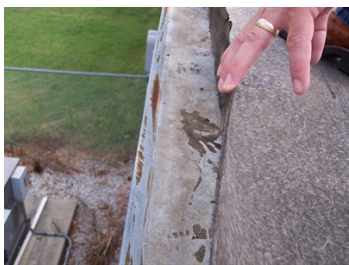
A small collection trough around the 660' perimeter of the roof had mistakenly been "engineered" into the original installation. Water collected and eventually drained under the roof sheets toward the center of the building until it found a leak path onto the ceiling.

Application carried out according to Belzona Know-How System Leaflet RPA-1. After surface preparation a fully reinforced Belzona® 3111 system was applied so that it overlapped onto the metal perimeter trim and the main roof covering.

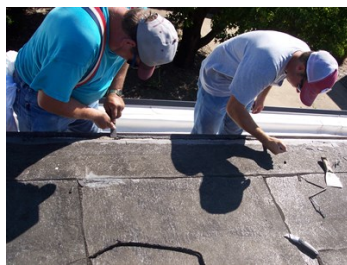
- \* The poor roof design allowing water to collect and enter ,
- \* Conditioning of metal trim and roof sheet ,
- \* Belzona® 3111 being applied through the Reinforcing Sheet ,
- \* Completed application with entire building perimeter sealed with Belzona Membrane System ,
