RESTORATION OF BRONZE IMPELLER WITH BELZONA

ID: 724

Application: CEP-Centrifugal Pumps

Customer Location: AEP/PSO - Oolagah, OK

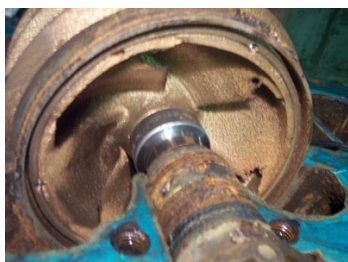
This pump impeller, 1 of 4, normally running 24/7 had eroded to the point of replacement.

- * First inspection showing extent of erosion damage ,
- * Mesh in place and rebuild proceeding ,
- * Grinding to contour ,
- * Rebuilt and ready for service ,
