RESTORATION OF BRONZE IMPELLER WITH BELZONA

ID: 724

Customer Location: AEP/PSO - Oolagah, OK
Application Date: June, 2005

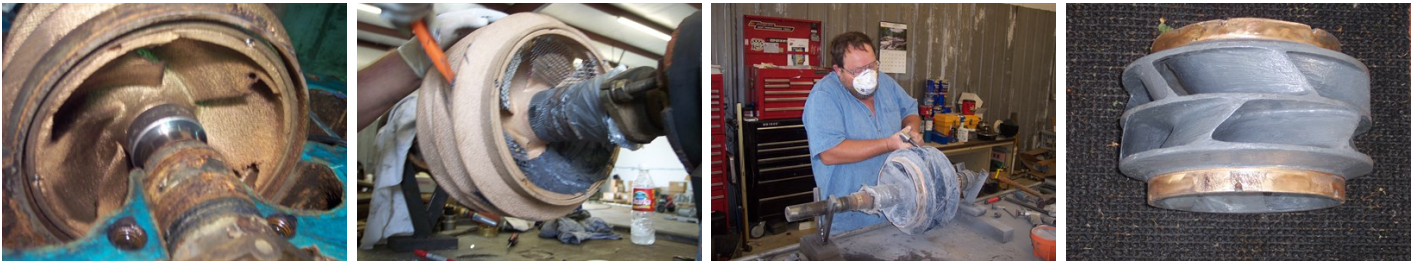
This pump impeller, 1 of 4, normally running 24/7 had eroded to the point of replacement.

- * First inspection showing extent of erosion damage ,
- * Mesh in place and rebuild proceeding ,
- * Grinding to contour ,
- * Rebuilt and ready for service ,

Application was carried out in accordance with Belzona Know-How System Leaflet CEP-1, CEP-3 and CEP-5. Stainless Steel mesh used to reform vanes. After rebuilding, grinding to original profiles and coating, impeller was re-balanced.
