# BELZONA MANWAY OPENING

Industry: Chemical & Petrochemical  
Application: TCC-Tanks and Chemical Containment Areas  
Substrate: Stainless Steel  
Products: \* Belzona® 1111 (Super Metal) ,

Customer Location: Petroleum Refinery in Texas  
Application Date: 1991

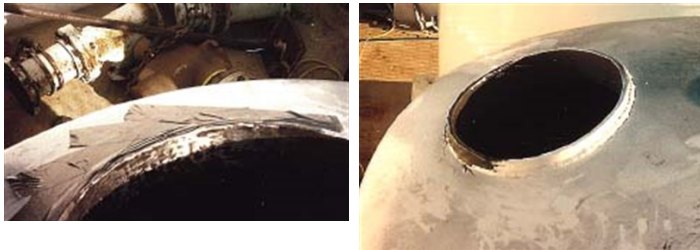
Opening on chemical tank was corroded to the point where a good seal was not possible.

- \* Surface preparation performed with the repair area taped off. ,
- \* Manway rebuilt. ,

The application was carried out in accordance with a modified version of Belzona Know-How Leaflet TCC-10.

For only \$128 in Belzona® 1111 (Super Metal), downtime and expensive welding was averted. The repair has held for many years, and is still in perfect condition.
