BELZONA REPAIR OF RUBBER IMPELLER

ID: 744

Industry: Water / Wastewater
Application: SHM-Solids Handling Machinery

Customer Location: Chemical Plant, Italy
Application Date: November 2005

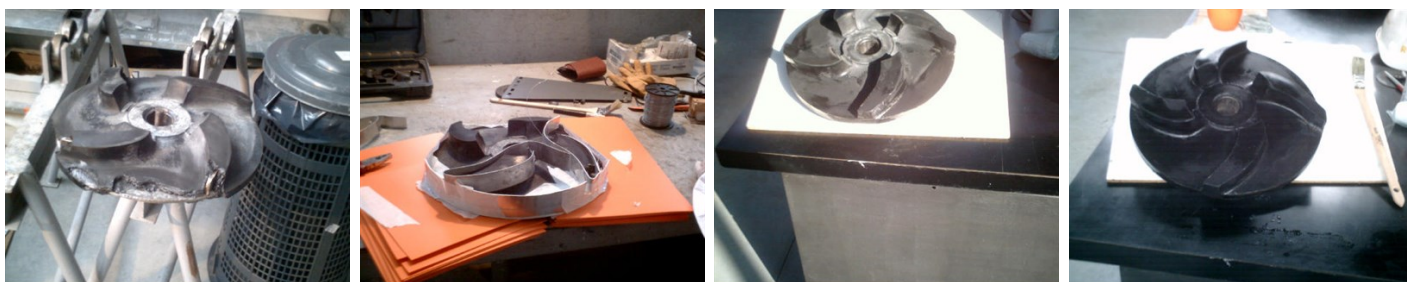
Photograph Descriptions

Whilst casing had little damage, the impeller vanes were very badly damaged and needed rebuilding.

- * The damaged impeller ,
- * Aluminum formers in place ,
- * Casting underway ,
- * The finished impeller ,

Rubber covered pump impeller.

Application was carried out in accordance with Belzona Know-How System Leaflet SHM-9. Aluminum forms were prepared and Belzona® 2131 poured in to restore profiles. Belzona® 2311 used to reform smaller areas.
