POSITIVE FEEDBACK ON BELZONA APPLICATION OF A SECONDARY CLARIFIER

ID: 7465

Customer Location: Water and Wastewater Treatment Plant,
Ontario, Canada

Application: TCC-Tanks and Chemical Containment
Areas

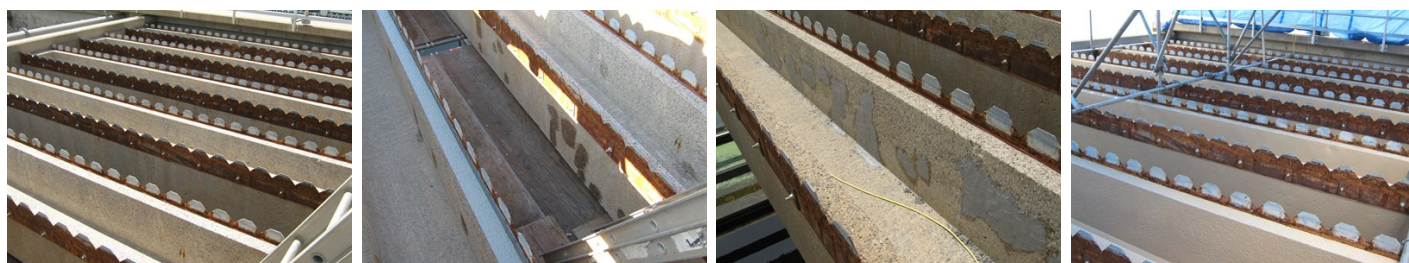
The secondary clarifiers at the Water Pollution Control Center were pitted and deteriorated due to chemical attack from the biological treatment process.

The tank was power washed and allowed to dry. Pits, cracks or holes were conditioned with Belzona 4911 and then filled with Belzona 4131 using a trowel. Once repaired, Belzona 5811 was applied to the entire internal part of the tank with rollers and brushes.

A second inspection was carried out in April 2024 and the coating is still holding well and protecting the weirs
