BELZONA SUPERWRAP II PROTECTS UNDERGROUND PIPELINE

Customer Location: Refinery, Shaanxi, China
Application Date: July 2016

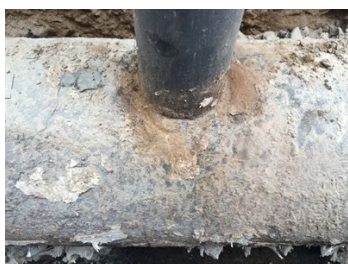
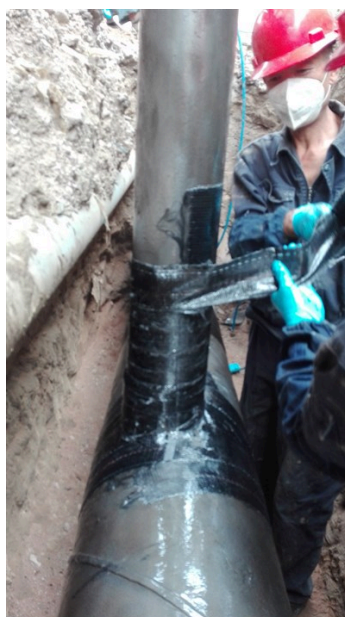
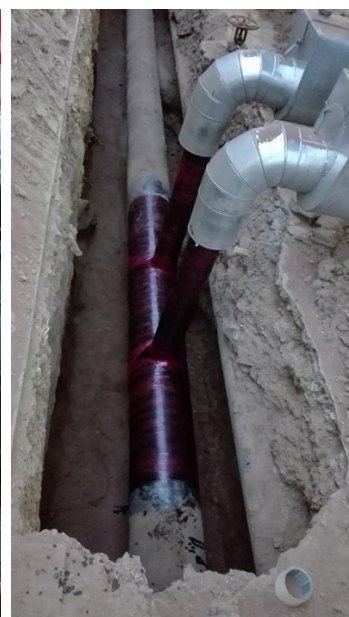
Photograph Descriptions

The pipe external wall had corroded due to the long-term humid environment. Pitting corrosion had led to significant wall thinning.

- * 1. Severe corrosion in the thinned-wall ,
- * 2. Surface preparation underway ,
- * 3. Application of Belzona SuperWrapII ,
- * 4. Application completed ,

The application was carried out by a validated installer following the specific design generated for this application.

This Belzona SuperWrap II application presented an effective and low-cost repair solution. Rather than expensive and time-consuming replacement of the whole pipeline, the Belzona SuperWrap II application required no hot work and was completed rapidly and with reliable results.
