BELZONA SUPERWRAP II PROTECTS UNDERGROUND PIPELINE

Industry: Chemical & Petrochemical
Application: VPF-Valves, Pipes and Fittings
Substrate: Carbon steel
Products: * Belzona 1161 (Super UW Metal) ,
* Belzona SuperWrap II ,

Customer Location: Refinery, Shaanxi, China
Application Date: July 2016

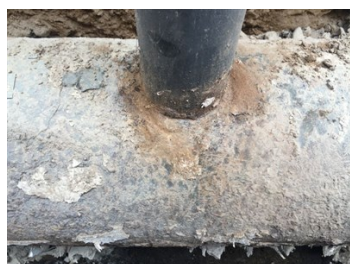
The pipe external wall had corroded due to the long-term humid environment. Pitting corrosion had led to significant wall thinning.

- * 1. Severe corrosion in the thinned-wall ,
- * 2. Surface preparation underway ,
- * 3. Application of Belzona SuperWrapII ,
- * 4. Application completed ,
