# BELZONA SUPERWRAP II PROTECTS UNDERGROUND PIPELINE

**Industry:** Chemical & Petrochemical  
**Application:** VPF-Valves, Pipes and Fittings  
**Substrate:** Carbon steel  
**Products:** \* Belzona 1161 (Super UW Metal) ,  
\* Belzona SuperWrap II ,

**Customer Location:** Refinery, Shaanxi, China  
**Application Date:** July 2016

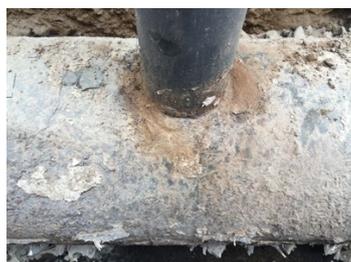
The pipe external wall had corroded due to the long-term humid environment. Pitting corrosion had led to significant wall thinning.

- \* 1. Severe corrosion in the thinned-wall ,
- \* 2. Surface preparation underway ,
- \* 3. Application of Belzona SuperWrapII ,
- \* 4. Application completed ,
