BELZONA QUICK EFFICIENT SOLUTION FOR FACTORY FLOOR

ID: 7472

Customer Location: Sausage skin factory, Hanko, Finland
Application Date: March 2017

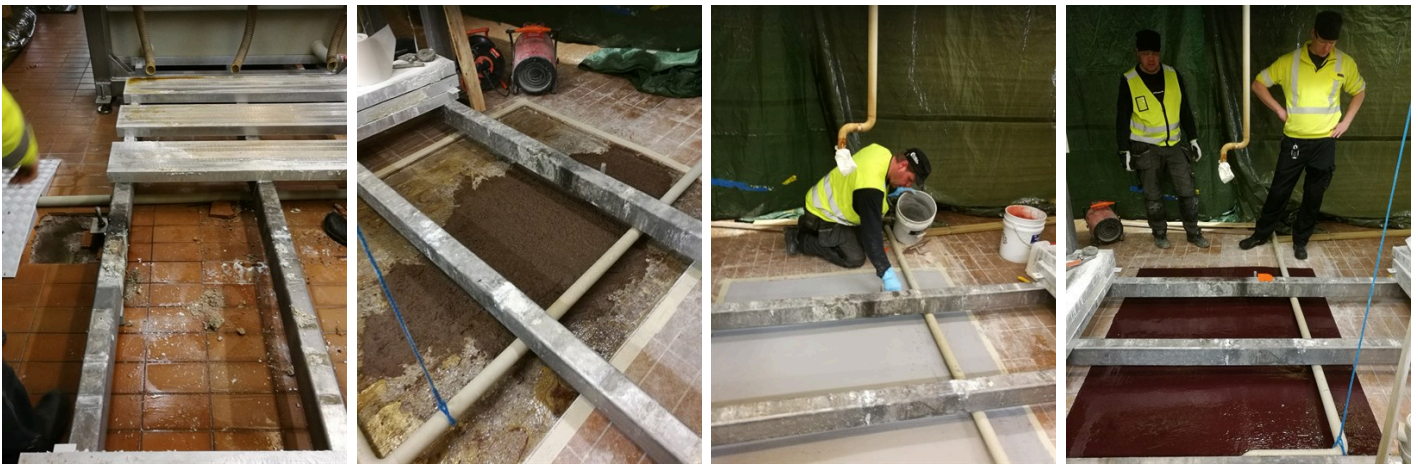
Photograph Descriptions

Chemicals were damaging the floor and attacking the grout between tiles. This particular problem area was a 3-4m² area underneath equipment with leakages. The repair had to be carried out in a 3 day window.

- * 1. Damaged tiles under equipment ,
- * 2. Belzona 4154 applied to infill deepest damage ,
- * 3. Application of Belzona 4111 to restore original levels ,
- * 4. Belzona 4311 coating applied for chemical resistance ,

Application was carried out in accordance with Belzona system Leaflets FPA-1 and FPA-3. Belzona 4154 was used to fill the larger, deeper areas (up to 100mm). Belzona 4111 was then applied before coating with Belzona 4311 to give a chemical resistant layer to prevent further chemical attack.

Belzona provided a cost-effective solution, which was fully applied in 2 days, 1 day quicker than planned. Cementitious materials would have taken 28 days to cure before a chemical resistant coating could be applied.
