# BELZONA PROTECTS SUGAR MILL DIFFUSER FROM ABRASION DAMAGE

**Industry:** Sugar  
**Application:** TCC-Tanks and Chemical Containment Areas  
**Substrate:** Carbon steel and hardened stainless steel  
**Products:** \* Belzona 1381 ,

**Customer Location:** Sugar Mill, Arcis Sur Aube, France  
**Application Date:** November 2016

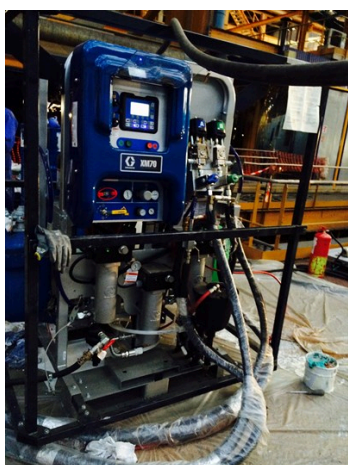
- \* Image 1 - The plural airless spray purchased by the Distributor to complete the application ,
- \* Image 2 - The sugar diffuser ,
- \* Image 3 - QR code for application video ,

The application procedure completed using a modified version of the system leaflet, TCC-5. The application saw 120-150 litres of Belzona 1381 applied to the diffuser at the ideal thickness of 1000 microns. A plural airless spray was used cover the region of over 100m<sup>2</sup>, split into 10m<sup>2</sup> patches. The application took 5 hours to spray apply but 10 days in total for rotating the diffuser to allow access and for surface preparation.

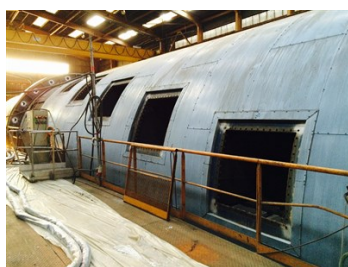
Sugar diffusers are notoriously difficult to protect because they offer limited access. However, they are highly susceptible to abrasion, accelerated by the high temperature of the water (up to 90°C (194°F)) and an added chemical. Therefore, protection is often necessary.

The client was looking for a durable protection of the diffuser. Previously, they had tried different organic coatings and welded stainless steel plates but none had provided satisfactory results. Whereas, after using Belzona 1381 for a year, the diffuser is still in perfect condition with the Belzona coating working flawlessly.
