PUMP SUMP PROTECTION WITH BELZONA ON OIL TANKER

ID: 748

Industry: Marine
Application: TCC-Tanks and Chemical Containment Areas
Substrate: Steel
Products: Belzona® 1391 (Ceramic HT Metal)

Customer Location: Oil Tanker owner, Palermo, Italy
Application Date: February 2006

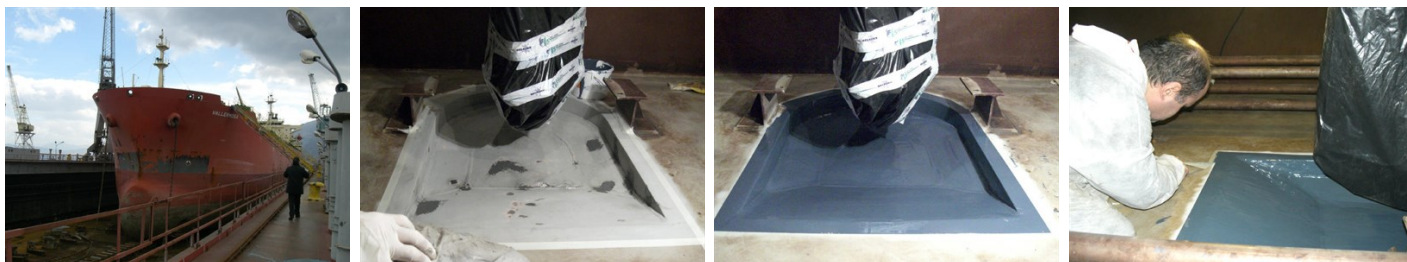
Photograph Descriptions

Erosion/Corrosion due to the constant liquid flow over the sump during cargo transfer.

* The tanker in dock. , * Sump after blasting. , * Sump coated with Belzona® 1391. , * Completing the application. ,

Sumps (suction wells) located underneath "Elephants feet" in cargo tanks.

Application was carried out in accordance with Belzona Know-How System Leaflet TCC-5.

This is a standard application carried out by a variety of owners and ship builders. The use of Belzona in this instance minimised dry-docking time. The Belzona® 1391 provides excellent erosion resistance when handling heated cargo.
