SO-CALLED "UNREPAIRABLE" PUMPS RESTORED WITH BELZONA

Industry: *Steel & Metal Processing*
Application: *CEP-Centrifugal Pumps*
Substrate: *Stainless Steel*
Products: ** Belzona 1311 (Ceramic R-Metal) ,*
** Belzona 1341 (Supermetalgilde) ,*

Customer Location: *Copper Processing Plant, Bulgaria*
Application Date: *2016*

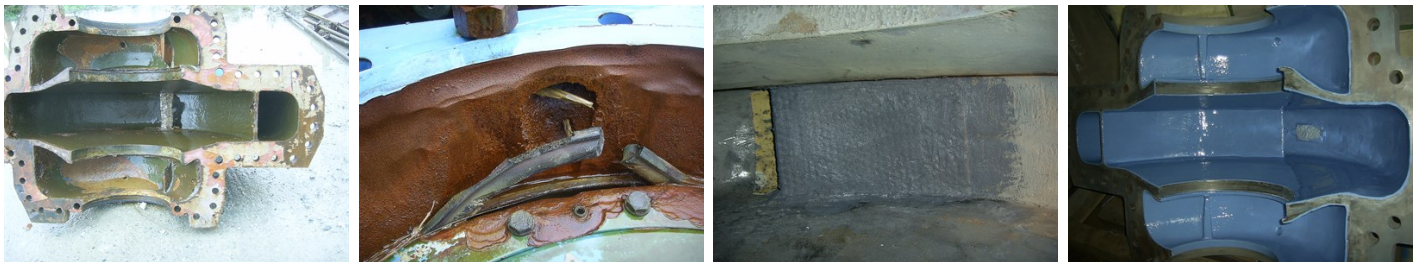
Photograph Descriptions

The pumps had to work 24 hours per day for a continuous period of 5500 hours (approximately 229 days). They were experiencing serious corrosion and some erosion from the cascade of return water from the dam containing active chemical reagents (pH from 2.5 to 8), as well as a small amount of solids.

- * 1&2. The corroded pumps
- * 3. The Belzona application underway with Belzona 1311 used to restore original profiles ,
- * 4. The completed application with Belzona 1341 applied to provide overall corrosion protection ,

Application was carried out in accordance with Belzona Know-How System Leaflets CEP-1, CEP-2 and CEP-3. 104 kilos of Belzona 1311 and 22 kilos Belzona 1341 were used.
