# Belzona Protects Blades Effectively against Abrasive Pulps

ID: 7485

Pulp-agitator blades in the chemical section of the phosphate mine.

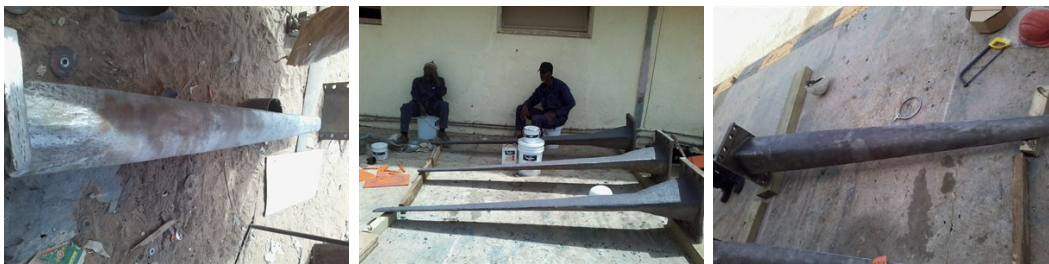
## Photograph Descriptions

*Severe blade abrasion*

- \* 1. Initial repair by welding. ,
- \* 2. Blades protected with Belzona 1812 ,
- \* 3. Blades inspected after 12 months in service ,

After removing the remainder of the rubber coating, the blades were welded on the heavily damaged areas. The surface was then grit-blasted before the application of Belzona 1812 according to the SHM-13 Belzona procedure.

Previously, the mine had to shut down the tank every month to replace the rubber-coated blades. Once coated with Belzona 1812, the blades were inspected after 12 months in service and were in good condition, requiring some retouching on about 10% of the surface: In 2017. the customer asked for a repair of 16 blades for other storage tanks.
