Belzona Protects Blades Effectively against Abrasive Pulps

ID: 7485

Industry: *Mining & Quarrying*
Application: *SHM-Solids Handling Machinery*

Customer Location: *Mines, Chemicals Sector, Senegal*
Application Date: *February 2016*

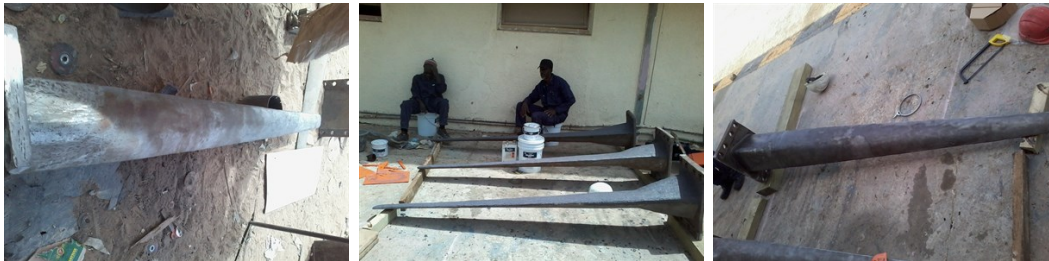
Photograph Descriptions

Severe blade abrasion

- * 1. Initial repair by welding. ,
- * 2. Blades protected with Belzona 1812 ,
- * 3. Blades inspected after 12 months in service ,

Pulp-agitator blades in the chemical section of the phosphate mine.

After removing the remainder of the rubber coating, the blades were welded on the heavily damaged areas. The surface was then grit-blasted before the application of Belzona 1812 according to the SHM-13 Belzona procedure.

Previously, the mine had to shut down the tank every month to replace the rubber-coated blades. Once coated with Belzona 1812, the blades were inspected after 12 months in service and were in good condition, requiring some retouching on about 10% of the surface: In 2017. the customer asked for a repair of 16 blades for other storage tanks.
