# Belzona Protects Screw Conveyor against Abrasion

ID: 7486

Industry: *Power*Customer Location: *Biomass power plant, France*Application: *SHM-Solids Handling Machinery*Application Date: *June 2015*Substrate: *Steel*Products: *\* Belzona 1311(Ceramic R-Metal) Belzona 1341 (Supermetalgilde) Belzona 9811 ,*

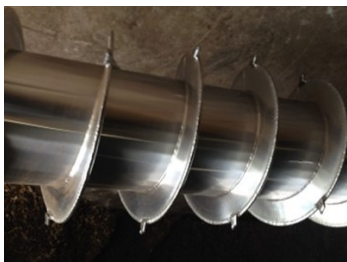
*Abrasion of welds. Welding of the screw every 12 months. Service life: 5 years*

- \* 1. Grit-blasted screw conveyor ,
- \* 2. Application of ceramic tiles on Belzona 1311 ,
- \* 3. Finished application ,

11 meter long stainless steel screw conveyor, tube Ø 700 for the transport of wood bark.

The surface was grit-blasted and a layer of Belzona 1311 was applied. Ceramic tiles were placed and coated with Belzona 1311. The surface was then grit-blasted and Belzona 1341 was applied in 2 layers.

Visit after 12 months: no visible abrasions or tile detachment
