Belzona Repairs Allow Offloading To Resume

ID: 7490

Customer Location: FPSO, Gabon
Application Date: June 2017

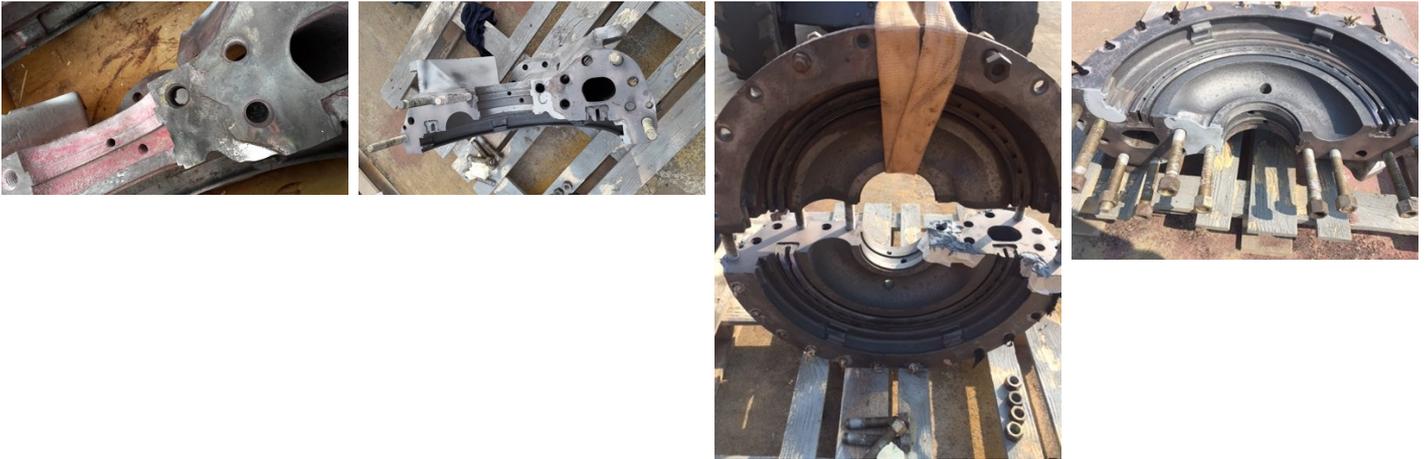
Photograph Descriptions

Corrosion and significant loss of metal on many areas of one half of the flange face.

- * 1. Localised damage on the flange face ,
- * 2. After surface preparation ,
- * 3. Forming in-operation using the other half of the split casing ,
- * 4. Finished result ,

Application was carried out in accordance with Belzona Know-How System Leaflet ENC-7.

The top half of the turbine was used as the former, allowing the repair to be completed in 5 hours. Prior to considering Belzona, the contractor had attempted to weld the area but it had proven impossible, leaving Belzona the only option before ordering a new turbine.
