# BELZONA RESTORES AND PROTECTS PUMP FROM FOOD INDUSTRY

ID: 7493

Industry: Food & Drink  
Application: CEP-Centrifugal Pumps  
Substrate: Steel  
Products: \* Belzona 1111 (Super Metal) ,  
\* Belzona 1321 (Ceramic S-Metal) ,

Customer Location: Food Company, South Africa  
Application Date: March 2017

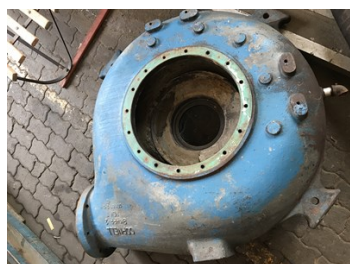
The existing coating was delaminating from the substrate and parts of this coating were going through the process which was unacceptable as it is a food application.

- \* 1 - Pump Casing before cleaning & blasting ,
- \* 2 - Pump Casing after coating work completed ,
- \* 3 - Pump Casing internals before repair ,
- \* 4 - Pump Casing internals after coating had been completed. ,

The application was carried out in accordance with Belzona System Leaflet CEP-3 and CEP-05. The old coating had to be removed. Once this was completed the substrate was suitably prepared by grit blasting. Belzona 1111 was applied to rebuild worn areas and Belzona 1321 was applied over the entire casing and backplate.
