Saving the belt with Belzona!

ID: 7497

Application: SHM-Solids Handling Machinery

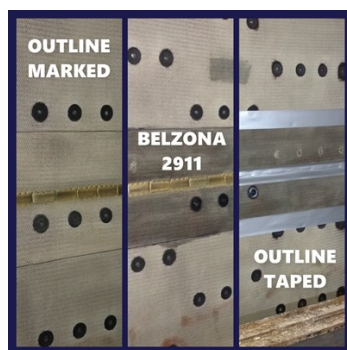
* 1. The silos. 2. Belt prep and Belzona 2911 QD Conditioner. 3. First layer of Belzona 2111 D&A Hi-Build Elastomer. 4. Application complete. ,
