Saving the belt with Belzona!

Application: SHM-Solids Handling Machinery

Application Date: June 2017

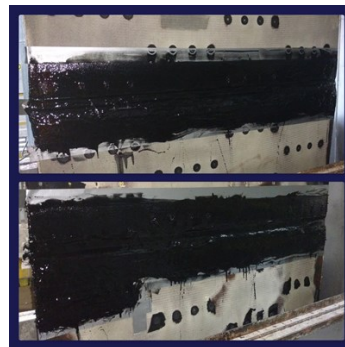
Corn and soybeans falling as the conveyor belt lifts the grains up was causing enough abrasion on the backside of this vertical belt to wear off a complete layer of rubber leaving the layer of the fiber exposed. The wear is worse right next to the joint actually wearing through the fiber layer.

* 1. The silos. 2. Belt prep and Belzona 2911 QD Conditioner. 3. First layer of Belzona 2111 D&A Hi-Build Elastomer. 4. Application complete. ,

Pressure washed the application area to remove debris and grain dust. Used a handheld wire brush to roughen the fiber surface as the majority of the rubber layer was loose and disbonded and was removed. The outline of the proposed application area was marked and the Belzona 2911 QD Conditioner was applied and allowed to dry per the IFU. Duct tape was applied over the joint seam to allow the application to bridge rather than adhere. The outline was also taped off just inside of where the conditioner was applied. Only one unit of Belzona 2111 D&A Hi-Build Elastomer was mixed at a time, the first batch used to wet out the application area, the second added some volume as well as wetting out the Belzona 9341 Reinforcing Sheet. The last batch smoothed out the application and covered the reinforcing sheet completely.
